Centennial Elementary

4201 25th Street S, Fargo, ND 58104

Existing Conditions

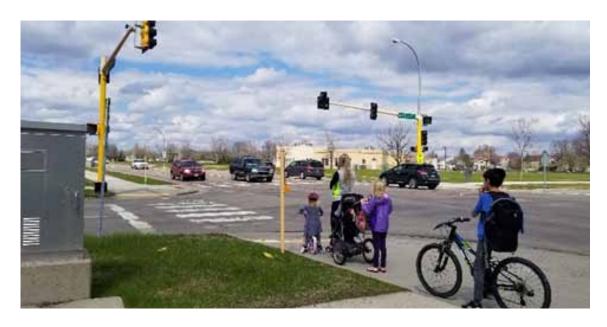
▲ The 40th Avenue S and 25th Street S intersection is very wide and sees poor driving yielding behavior when turning.

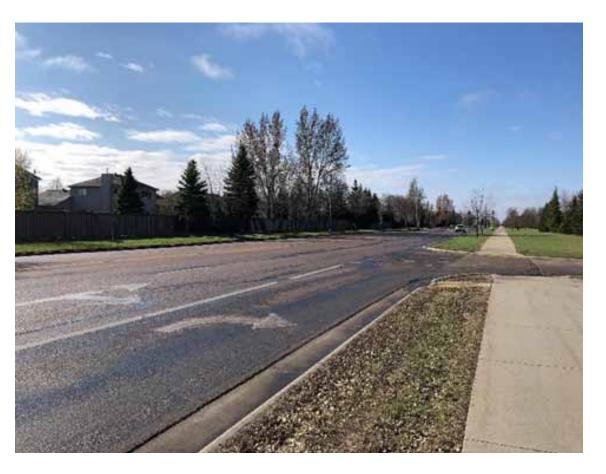
▲ From 25th Street S, there is a double right-turn. The driveway is very wide with no marked crosswalk.

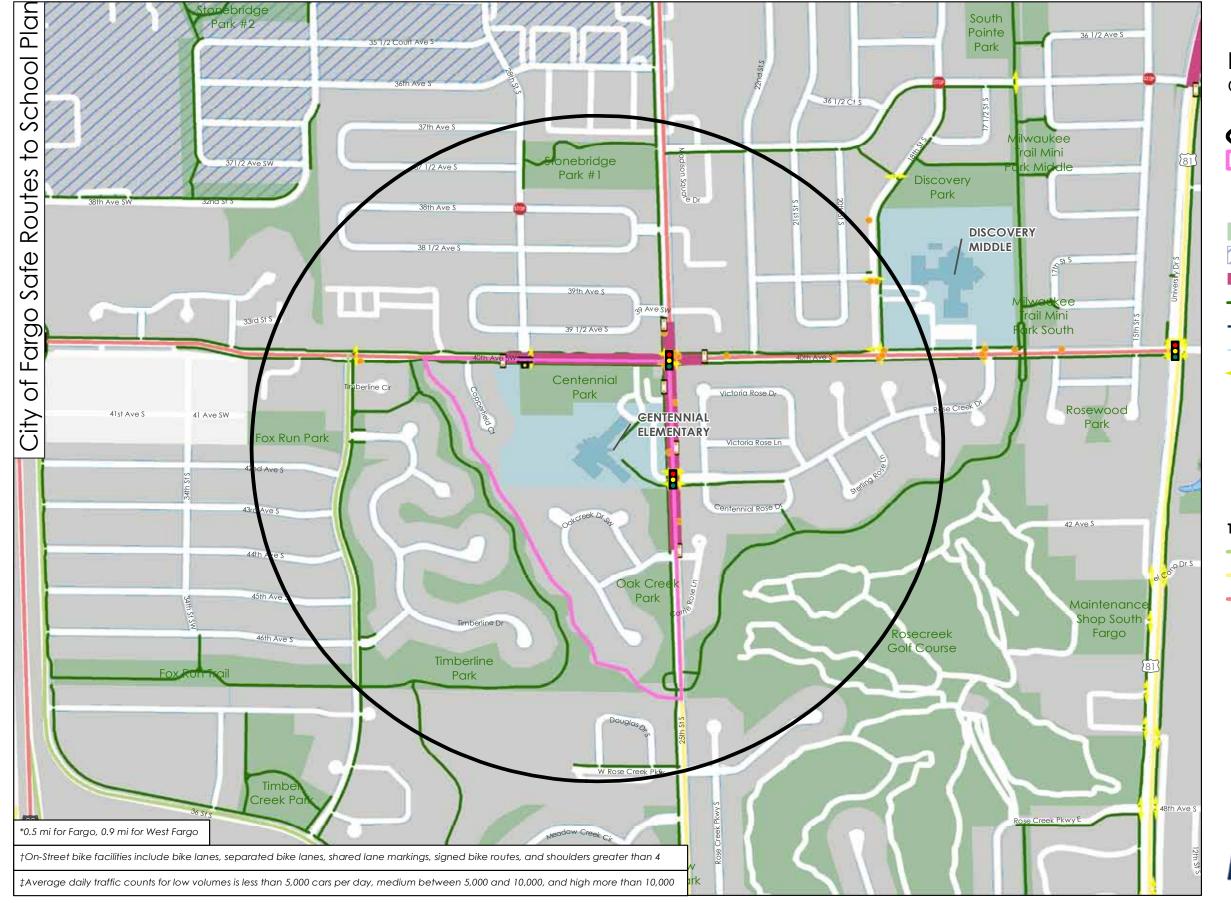
Existing Conditions Centennial Elementary

The intersection of 40th Avenue S and 25th Street S (both minor arterial roadways) is adjacent to the Centennial Elementary campus. This intersection was observed with poor driver yielding behavior and long delays for pedestrians and cyclists. The 25th Street S and Rose Creek Drive intersection also presents a crossing challenge, where pedestrians and cyclists have long delays waiting for a walk signal. Neither intersection has a leading pedestrian interval, which could improve pedestrian visibility and safety.

The 25th Street S entrance to the drop-off loop features a long pedestrian crossing with a double right turn for southbound 25th Street S traffic. This is a potential safety challenge. Drivers were also observed speeding in the 25th Street S speed zone during school arrival and dismissal observations.

There are multiple comb style bike racks at Centennial Elementary that are well used and placed at the front of the building, encouraging use.

West of the campus is a drain that creates a barrier to the housing developments west of the drain from the school. There is also a shared-use path that runs along the west side of the drain. A connection over the drain could make walking and biking easier for more students and provide an alternative to busing for these students.

CENTENNIAL ELEMENTARY CHALLENGES				
LOCATION		CHALLENGE		
Α	40th Ave S / 25th St S	Long crossing distances		
		Poor driver yielding behavior of turning traffic		
		Long wait for pedestrian crossing signal		
		No leading pedestrian interval		
		Damaged truncated domes		
В	Rose Creek Dr / 25th St S	Signal requires push button for walk sign		
		Faded crosswalk markings		
		No leading pedestrian interval		
С	Front of School	Comb style rack does not allow locking of frame and can lead to wheel damage		
D	Front of School	Comb style rack does not allow locking of frame and can lead to wheel damage		
E	25th St S at entrance driveway	Double right turn from street		
		Long crossing distances and exposure in apron		
		No marked crosswalk across driveway		
F	40th Ave S between 25th and 28th St S	No lights present on sign that says speed zone "when flashing"		
G	40th Ave S / bus loop entrance	Unmarked crosswalk of major driveway on popular route to / from school

н	West of school	No connection from trail to campus		
ı	40th Ave S between 25th and 28th St S	Absent school zone sign on south side of the street, even though this is in the speed zone

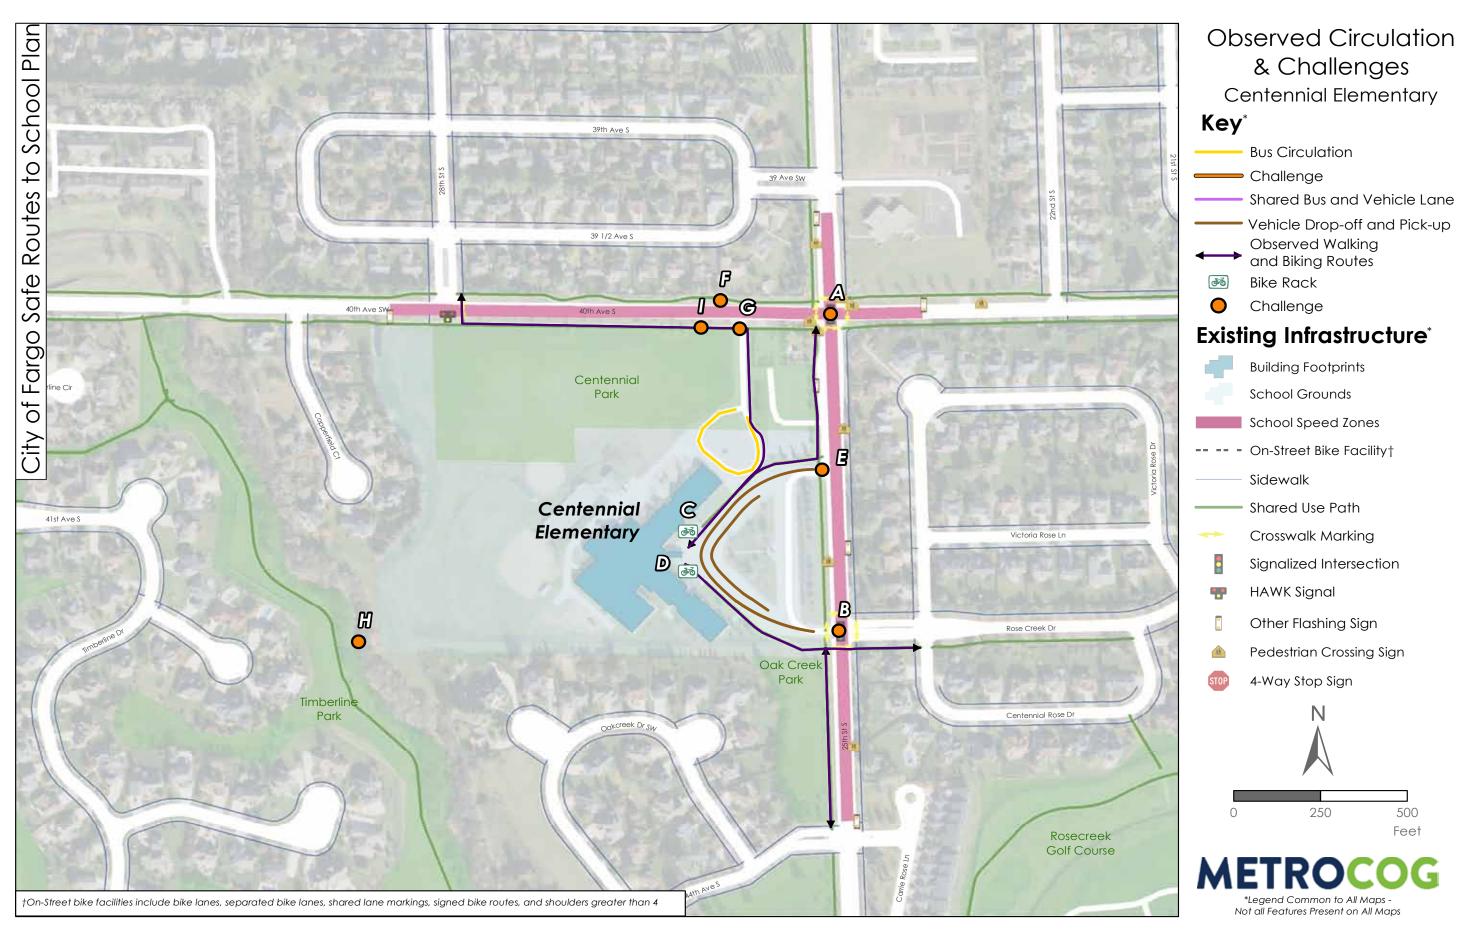
Infrastructure Opportunities Centennial Elementary

Since both 40th Avenue S and 25th Street S are minor arterial roadways and present barriers for safe and comfortable walking and biking to school, the majority of the opportunities for improvement relate to these two streets. At the intersections of 40th Avenue S and 25th Street S and 25th Street S and Rose Creek Drive, there is an opportunity to utilize the existing traffic signals to incorporate leading pedestrian intervals (LPI), which can increase the visibility of people walking through this intersection and improve driver yielding rates. Installing a NO RIGHT TURN ON RED sign at 25th Street S and Rose Creek Drive is recommended in combination with the installation of the LPI. Other opportunities for improvement include providing consistency with the application of school speed zones, including posting signs on both sides of the street and including flashing lights indicating when the school speed zone is in effect. Where possible, lanes should be reduced along 25th Street S to reduce multiple-threat collision opportunities.

On campus, there are opportunities to improve connections from the sidewalk to the school entrance, including marking high-visibility crosswalks at the school driveways.

CENTENNIAL ELEMENTARY OPPORTUNITIES FOR IMPROVEMENT						
LOCATION		POTENTIAL SOLUTION	LEAD AGENCY	IMPACT		
Α	40th Ave \$ / 25th \$t \$	Install leading pedestrian interval; reduce lane widths on 40th Ave S; replace damaged truncated domes (SW quadrant)	City of Fargo	High		
В	Rose Creek Dr / 25th St S	Install no right turn on red during school hours; install leading pedestrian interval; replace faded crosswalk markings	City of Fargo	High		
С	Front of school	Install bike parking to provide two points of contact with bicycle frame (e.g., Inverted U or Post and Ring style rack); consider installing additional capacity	Fargo Public Schools	Low		
D	Front of school	Install bike parking to provide two points of contact with bicycle frame (e.g., Inverted U or Post and Ring style rack); consider installing additional capacity	Fargo Public Schools	Low		
E	25th St S at entrance driveway	Install high visibility crosswalk across driveway; eliminate southbound right turn from middle lane to remove multiple threat crash opportunity and reduce crossing distance of driveway	City of Fargo; Fargo Public Schools	Medium

F	40th Ave S between 25th and 28th St S	Install flashing lights to provide indication to motorists of when the school speed limit is active (make consistent with other signs near the school)	City of Fargo	High		
G	40th Ave S / bus loop entrance	Install high visibility crosswalk across driveway to connect to sidewalk on the east side of the driveway	City of Fargo; Fargo Public Schools	High		
Н	West of school	Consider bridge connection from school campus to Timberline Park and residential area to the west	City of Fargo; Fargo Public Schools	Low		
I	40th Ave S between 25th and 28th St S	Install school zone sign with lights to alert motorists that they are in school speed zone	City of Fargo	High
