12th Avenue South Corridor Study River Drive to Main Avenue SE

APRIL 2019

METROCOG
FM REGIONAL TRANSPORTATION PLANNING ORGANIZATION

Draft Document

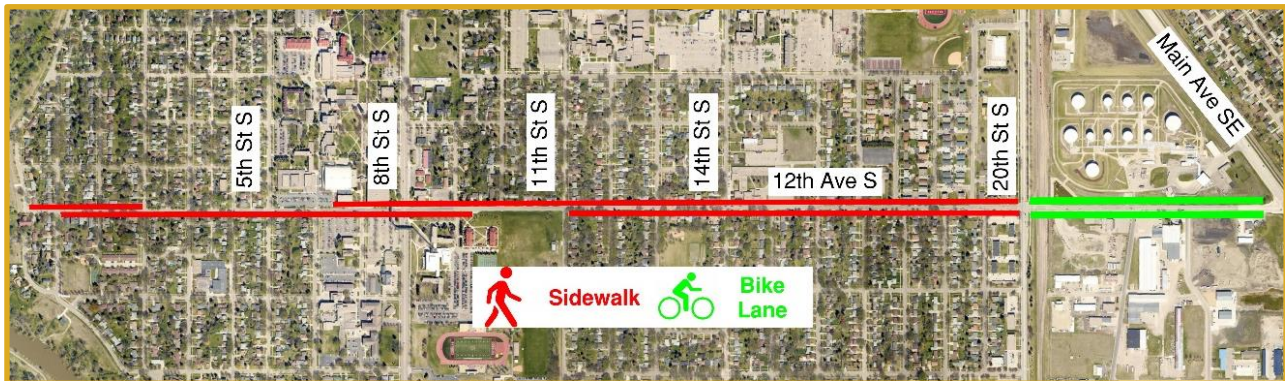
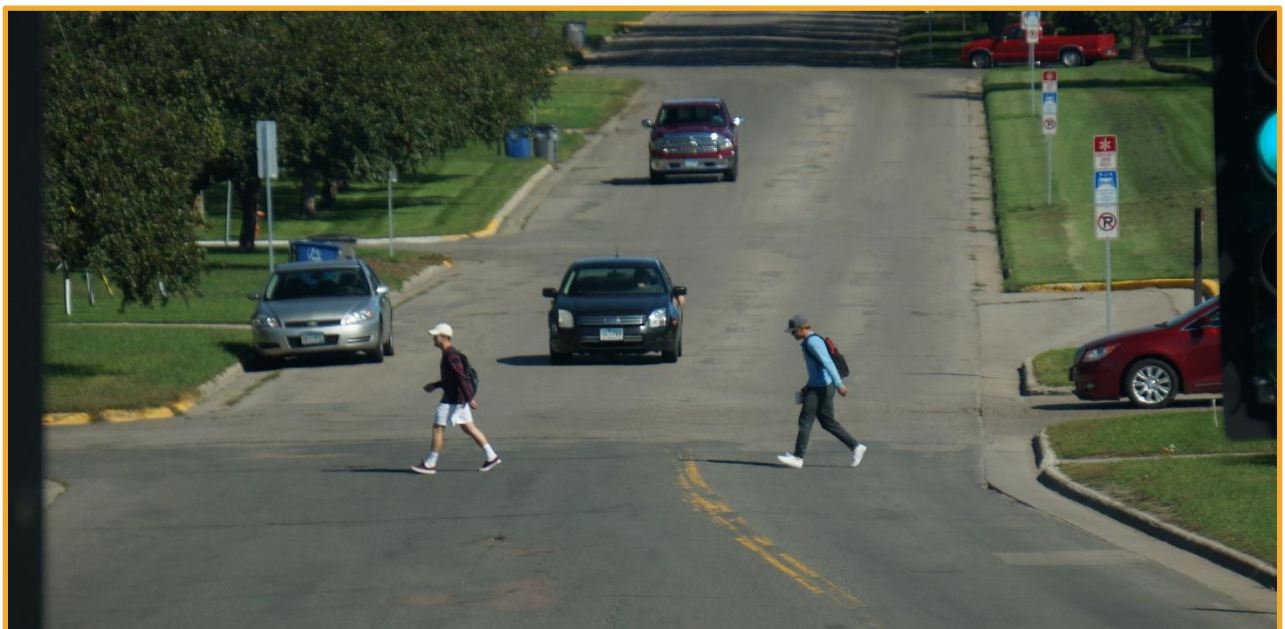
Figure 3.4 | Sidewalks and Bike Lanes

Figure 3.4 shows the existing sidewalk and bike lane facilities along the 12th Avenue South corridor. **Figure 3.5** on the next page shows the existing pedestrian volumes at each intersection for the AM Peak, PM Peak and Daily totals. The signals at the intersections with 8th Street S, 20th Street S and Main Avenue SE accommodate pedestrian crossings in each direction. In addition, throughout the corridor there are either signed or painted crosswalks at the following locations:

- 3rd Street S – signed crosswalk
- 4th Street S – painted crosswalk
- 5th Street S – painted crosswalk
- 6th Street S – signed crosswalk
- 7th Street S – signed and painted crosswalk

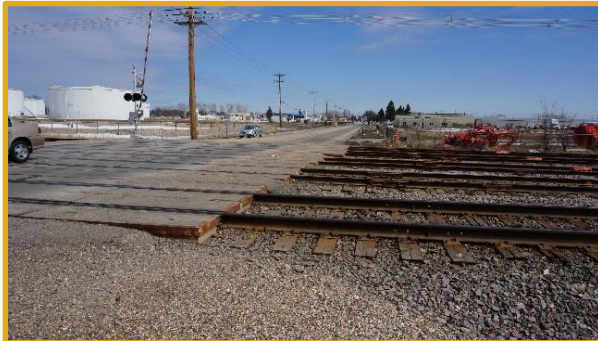
BNSF RR Crossing east of 20th Street

Both crossings are signalized and gated. Photos of each crossing can be found below.

There have been no accidents at either of these crossings since 1990, according to the data provided on the Federal Railroad Administration’s database.

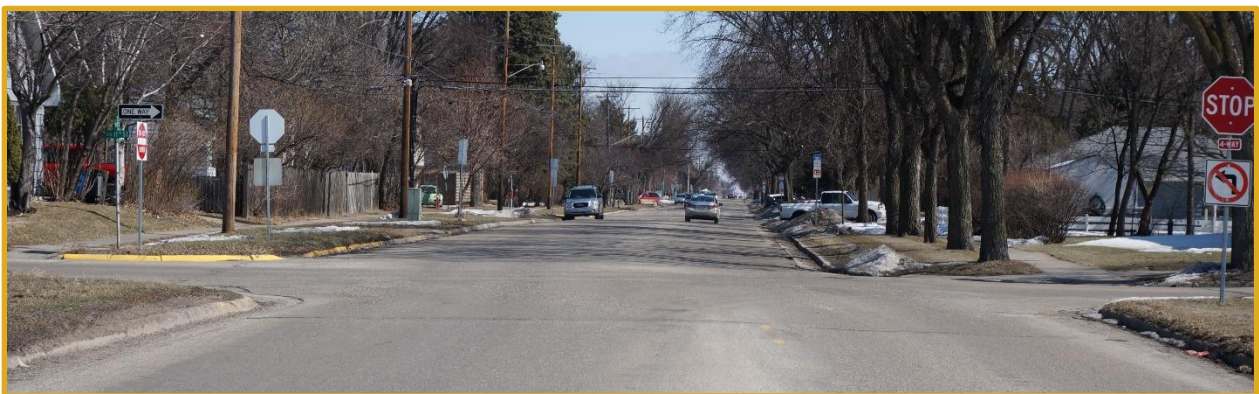
11th Street South Intersection, Facing East

The intersections at 11th Street South and 20th Street South could be improved to provide more desirable geometric features including horizontal or vertical alignment adjustments. At the intersection of 12th Avenue South and 11th Street South, 12th Avenue is offset 10 feet horizontally across the intersection. Moorhead City Code 11-5-7 prohibits intersection jogs with centerline jogs of less than 150 feet. There are several streets intersecting 12th Avenue South with a centerline jog, though the impacts of realigning those streets would be significant.

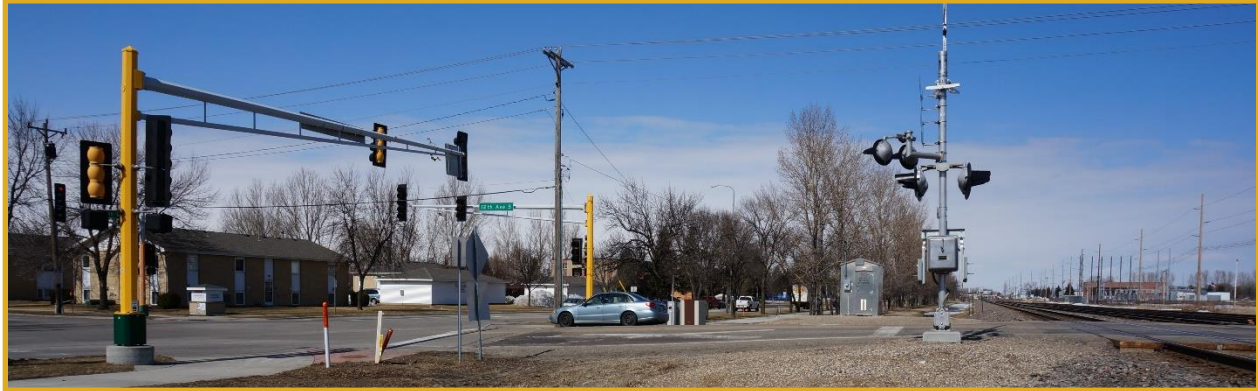
20th Street South Intersection, Facing North

At the 20th Street South intersection, there is a 3 foot vertical profile change between the intersection and the BNSF Railroad tracks 60 feet to the east. This vertical grade change combined with steep cross slopes can cause buses and other large vehicles stopped at the railroad tracks to lose traction and slide off the roadway in winter conditions.

The BNSF Railroad crossing east of 20th Street South should also be considered for quiet zone improvements. This location was evaluated in the City’s previous *Quiet Zone Study*. Future improvements should be reflective of the recommendations of that study, accounting for any changes in current conditions.

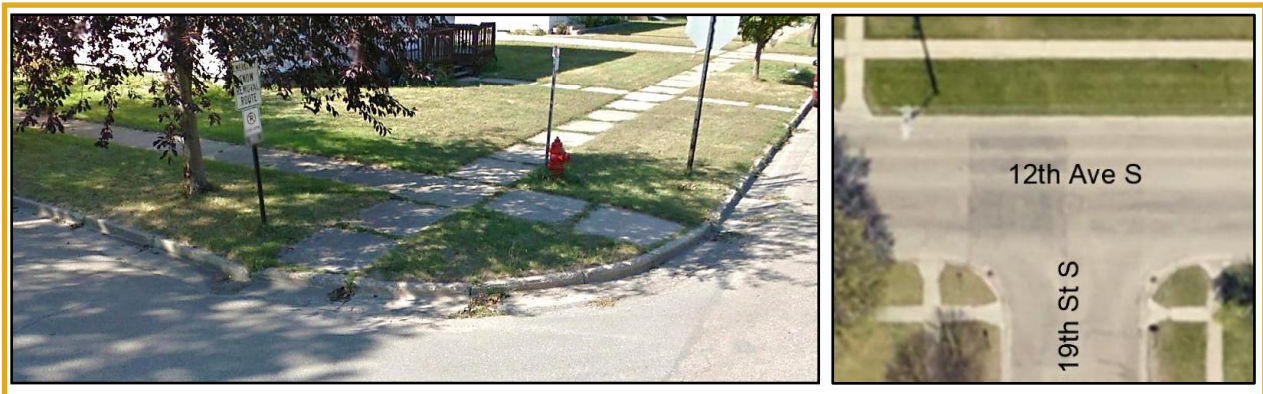
Many Sidewalk Curb Ramps Do Not Meet Current ADA Guidelines or Do Not Align

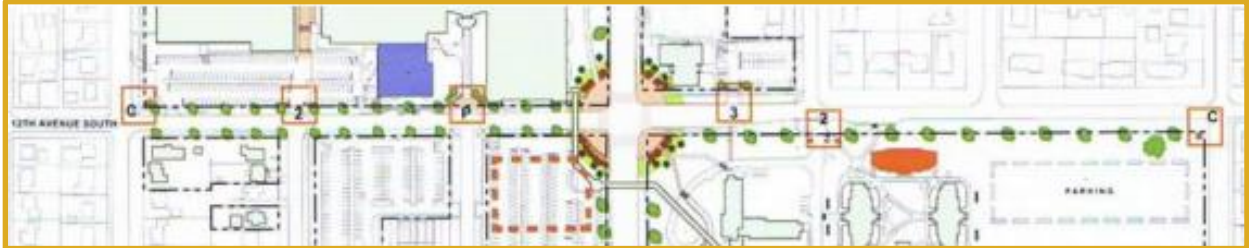
- Campus Identification at 5th Street South and 11th Street South
- Vehicular Gateway to parking lots between 8th Street South and 9th Street South
- Landscape Improvement from 5th Street South to 11th Street South

Figure 5.1 | Concordia Master Plan at 12th Avenue South and 8th Street South

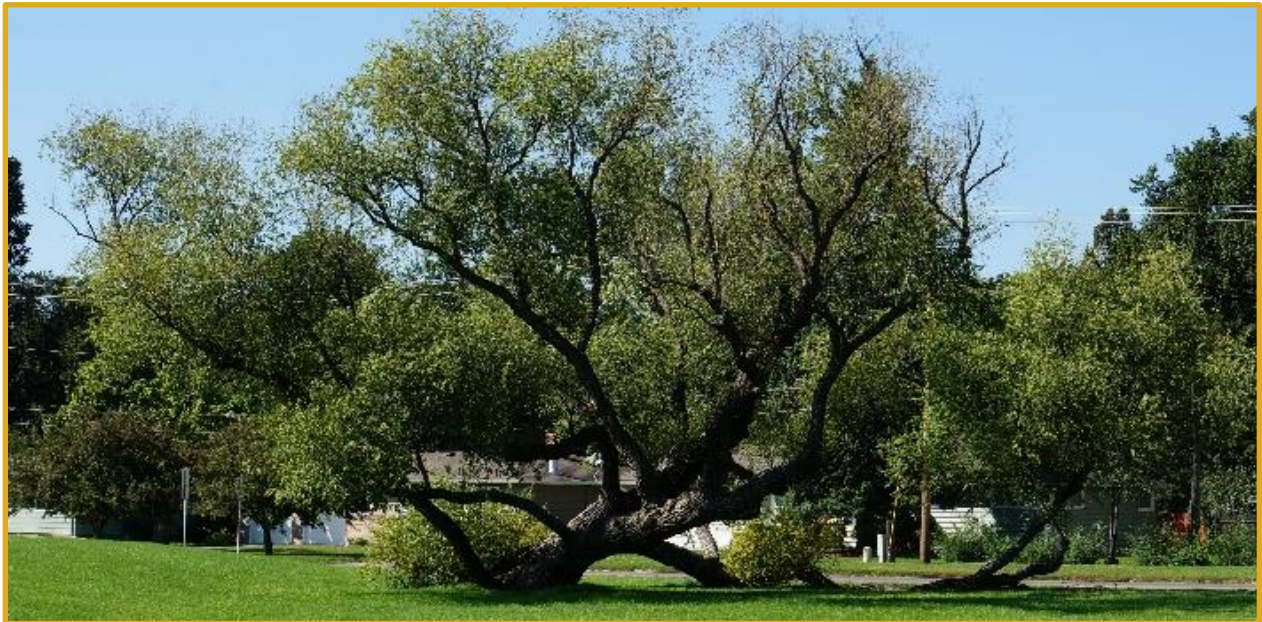
The "Crazy Tree" is a Local Landmark

The very large, multi-trunk tree is very popular in the community because of its unusual form, size and age. The trunks are very large diameter and are laying in a nearly horizontal configuration that makes for a unique and interesting form. The tree is visited often, is popular for photography, and is frequently climbed on.

The tree is in a lawn area, with a low levee located directly to the southwest of the tree. There are soccer fields located further southwest. The tree was pruned in 2017 to remove dead wood.

The “Crazy Tree” is a local landmark located in the southwest corner of 12th Avenue South and 11th Street. Because of the historical and social nature of this tree, the alternatives were developed for that area focused on reducing or eliminating impacts to the tree.

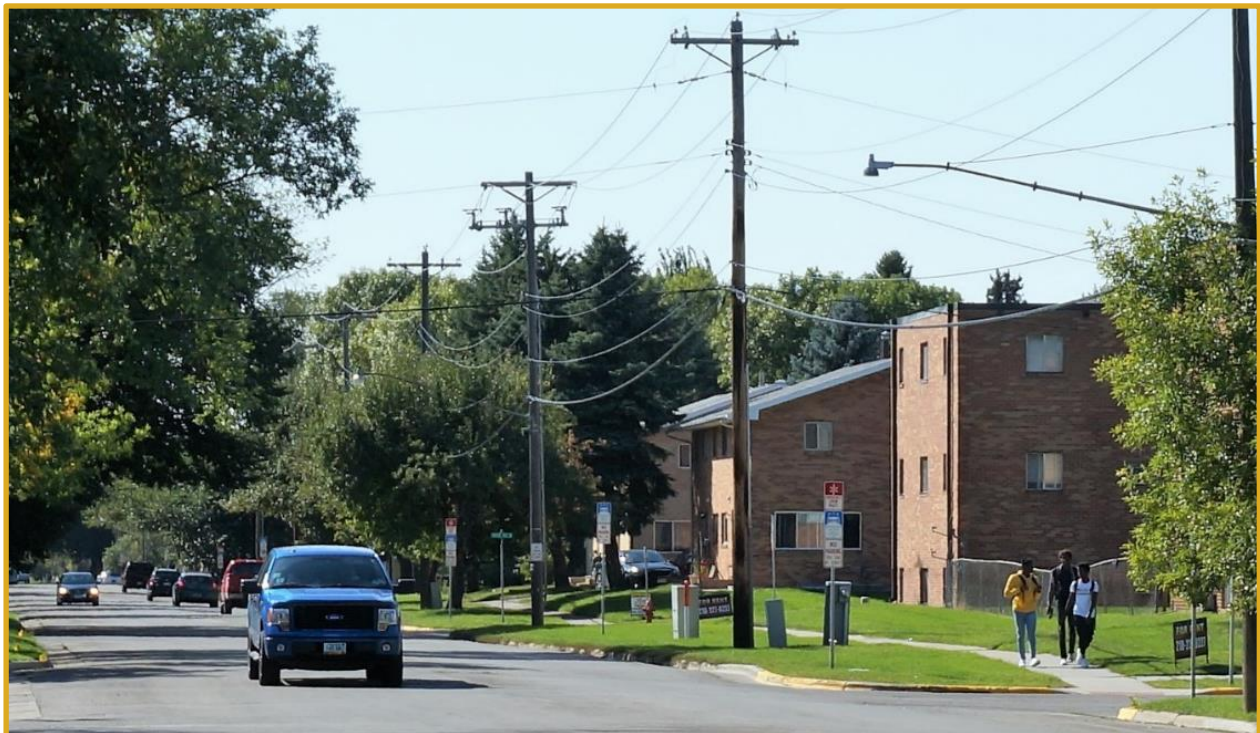
A final issue that impacts not only trees, but also several other areas of need, is the presence of overhead power lines owned by Moorhead Public Service in the north boulevard along over 80% of the corridor. Existing trees require continual trimming to prevent limbs from damaging the lines. The location of the poles in the boulevard also limits the feasibility of any significant improvements or changes to the north side of 12th Avenue.

Overhead Power Lines are Strung through Mature Trees Along the 12th Avenue South Corridor
