Technical Memorandum 1- Existing Conditions

Highway 10 through Dilworth Corridor Study

Fargo Moorhead Metro COG, MnDOT, and the City of Dilworth

July, 2022

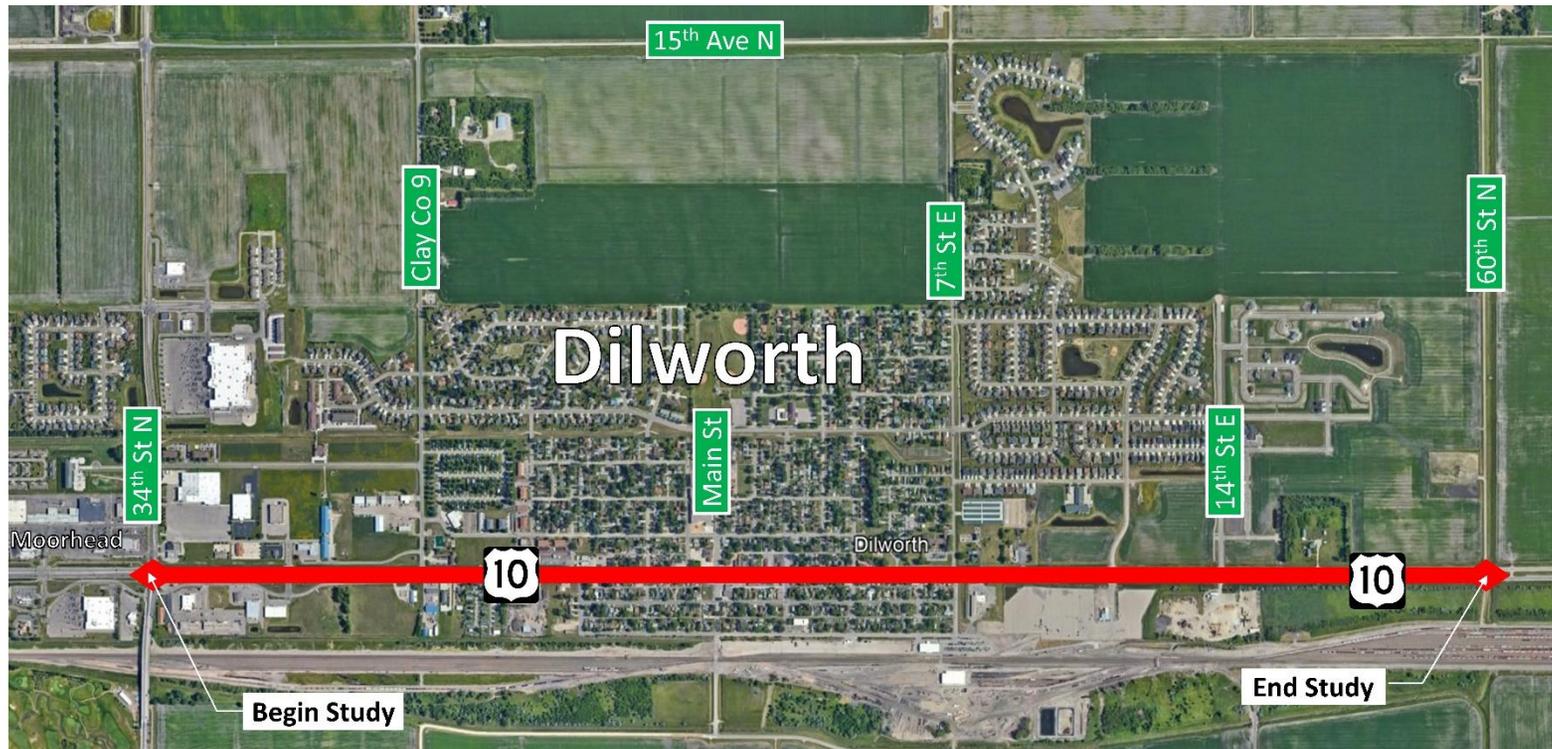
Figure 1 Study Location

Highway 10 serves as the main roadway to and through the City of Dilworth, with connections to I-94 via 34th Street on the west side of Dilworth and MN State Highway 336 on the east side. Highway 10 is a 4-lane divided/undivided Principal Arterial roadway that runs east-west with the speed limit transitioning from west to east through the corridor from 45 mph at 34th Street N, to 30 mph at 5th Street NW, to 65 mph near 7th Street NE. The study area has one zone of on-street parking and intermittent sidewalks. Different land uses exist along the corridor that include commercial, industrial, residential, and public park zoning.

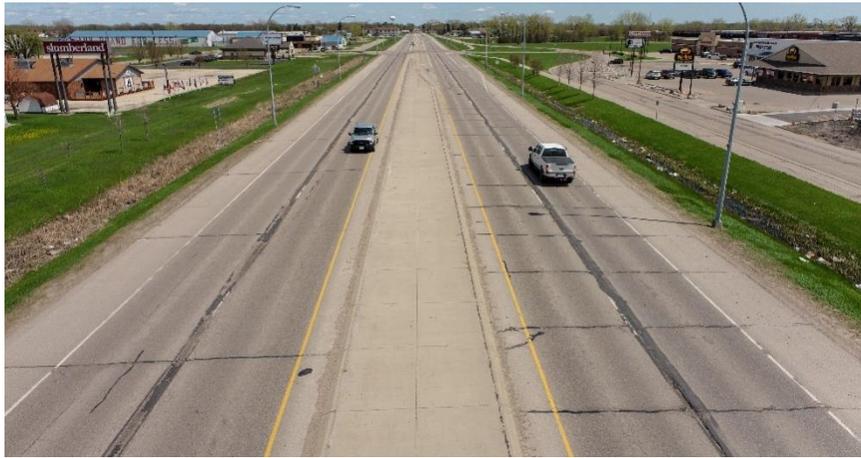
Segment	Notes	
<p>34th Street to 4th Street W</p>	<ul style="list-style-type: none"> • Divided 4-lane roadway with raised concrete median • 12' driving lanes with 8' outside and 4' inside shoulders, 16' median (88' pavement total) • Turn lanes • 45 mph speed limit • Frontage roads • 8' wide sidewalk on south side • 155' Right of Way <p>Segment Pavement Breakdown:</p> <ul style="list-style-type: none"> • Pavement – 5" bituminous pavement • Base – 8" concrete Base

34th Street to 4^h Street W – The existing pavement in this segment is showing signs of transverse cracking, longitudinal cracking, longitudinal joint distress, rutting and weathering. Curb and gutter located in the median is in average to below average condition. Weeds and grass are growing in the concrete median joints.

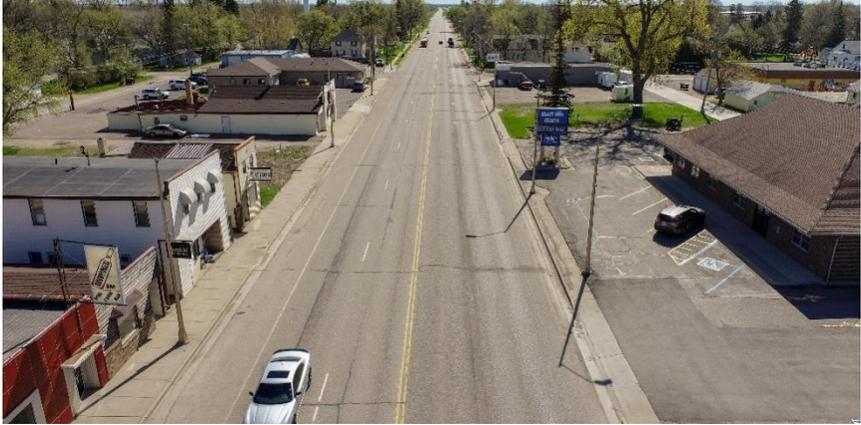
<p>4th Street W to 7th Street E</p>	<ul style="list-style-type: none"> • Undivided 4-lane roadway • 12'-14' driving lanes, 8' 10" parking lane on north side of road from Main Street to 3rd Street W (58' 10" pavement total) • No turn lanes • 35 mph speed limit • Sidewalks located on north and south side various widths • 76' Right of Way <p>Segment Pavement Breakdown:</p> <ul style="list-style-type: none"> • Pavement – 4"-5" bituminous pavement • Base – 7"-8" concrete/gravel base

4th Street W to 7th Street E – The existing pavement in this segment is showing signs of transverse cracking, longitudinal cracking, longitudinal joint distress, and weathering. Curb and gutter in the corridor shows signs of pitting and distress. Sidewalk in this segment is not ADA compliant. Non-compliance includes ramps, cross slope, and PAR width. Driveway cuts in this corridor do not facilitate a way for a wheelchair to transverse safely.

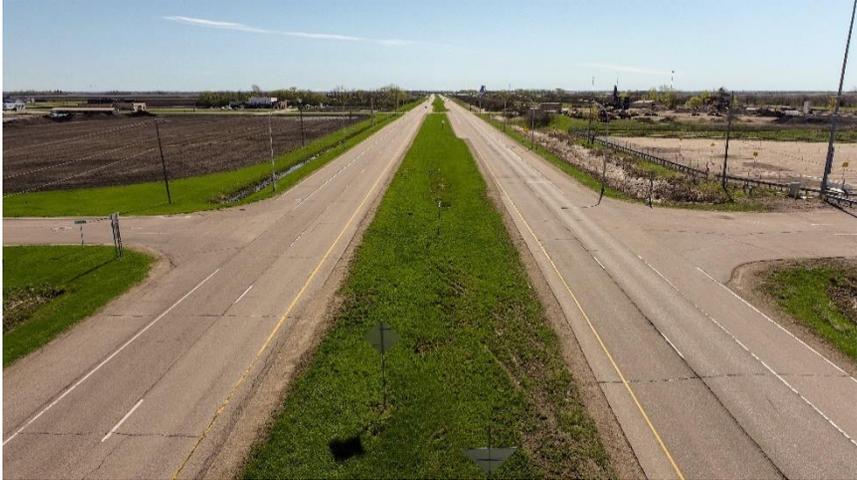
<p>7th Street E to 60th Street</p>	<ul style="list-style-type: none"> • Divided 4-lane roadway with a 46' grass median • Two 12' driving lanes. 10' and 4' shoulders (38' pavement total each roadway) • Turn lanes • 65 mph speed limit • No sidewalks • 256' Right of Way <p>EB Segment Pavement Breakdown:</p> <ul style="list-style-type: none"> • Pavement – 2" - 3" bituminous pavement • Base – 8" concrete base <p>WB Segment Pavement Breakdown:</p> <ul style="list-style-type: none"> • Pavement – 6" bituminous pavement • Base – 8" concrete base

7th Street E to 60th Street - The existing pavement in this segment is showing signs of transverse cracking, longitudinal cracking, longitudinal joint distress, and weathering. Curb and gutter in this section shows signs of pitting and distress. Weeds and grass are growing in the concrete median joints.

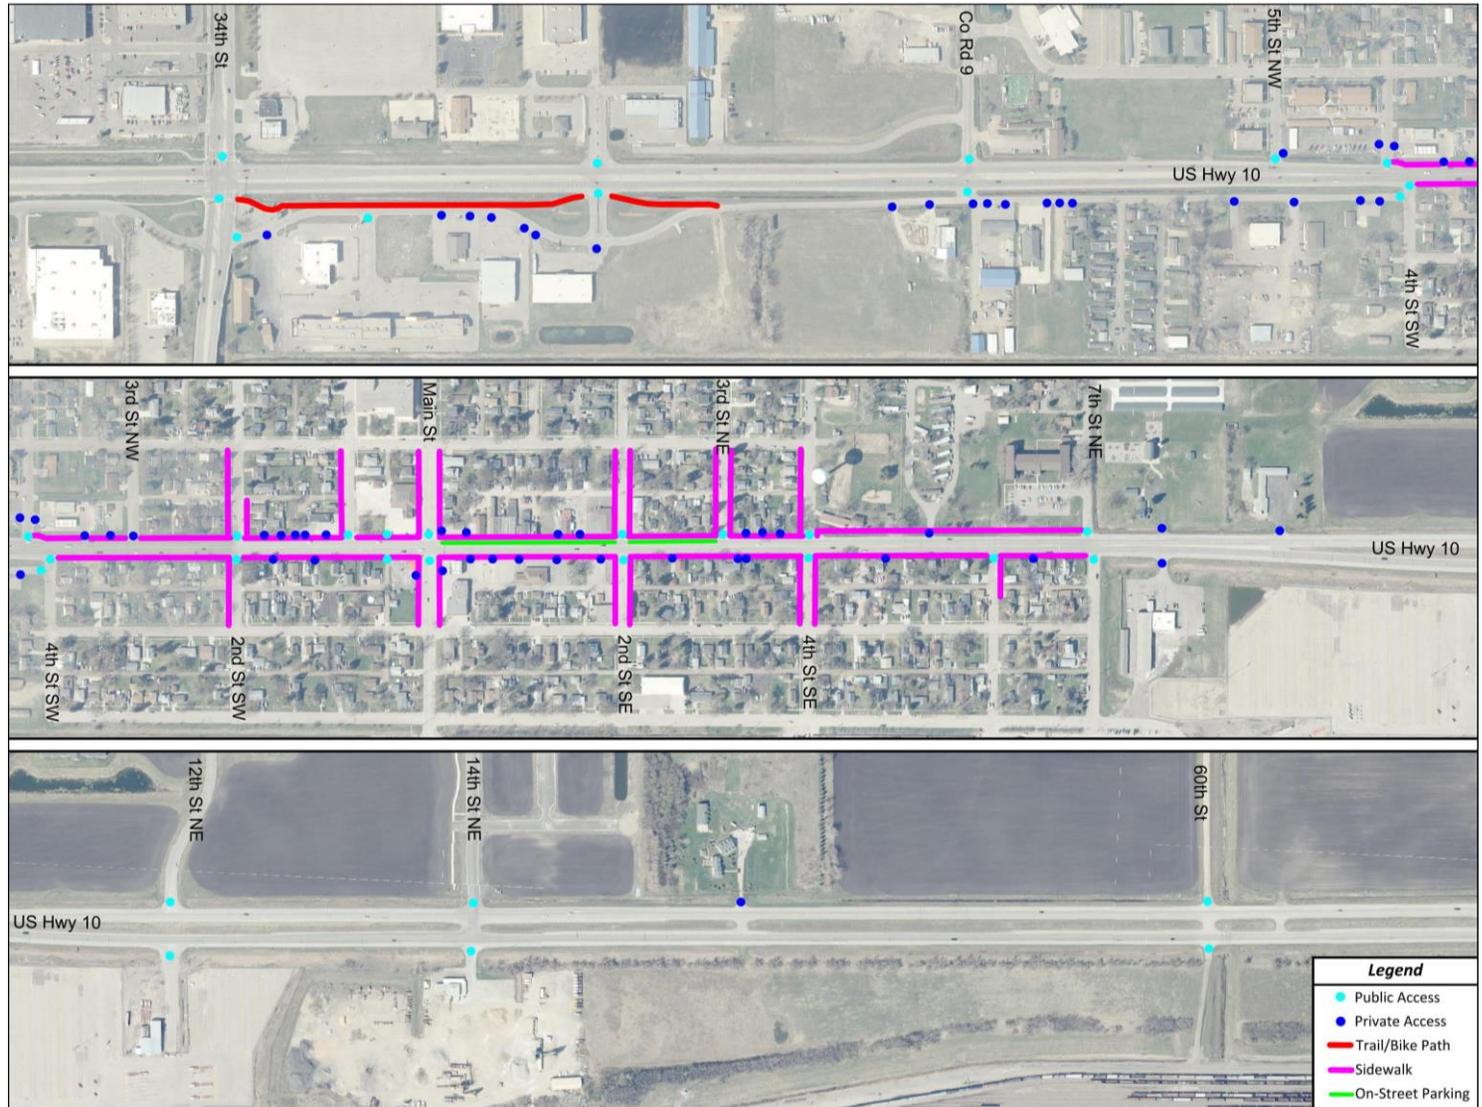
Figure 2 Access, Parking, and Sidewalks

The location and type of access points along the corridor are shown on **Figure 2**. There are 61 total direct access points on the 2.5 mile corridor, equating to an average of 24 accesses per mile. 31 of the access points are to private property, 30 are public roads (considering the north and south sides of a full intersection as separate accesses). The highest concentration is between 4th Street W and 4th Street E where there are 38 access points within a half mile.

- 34th Street to County Rd 9 – intermittent 8 foot sidewalk on the south side of Highway 10, no sidewalk on the north side.
- County Rd 9 to 4th Street W – No sidewalks present.
- 4th Street W to Main Street – 4 foot sidewalk on both the north and south sides.
- Main Street to 2nd Street E – 8 foot sidewalk on the north side and 4 foot sidewalk on the south side.
- 2nd Street E to 7th Street E – 4 foot sidewalk on both the north and south sides.
- 7th Street E to 60th Street – No sidewalks present.

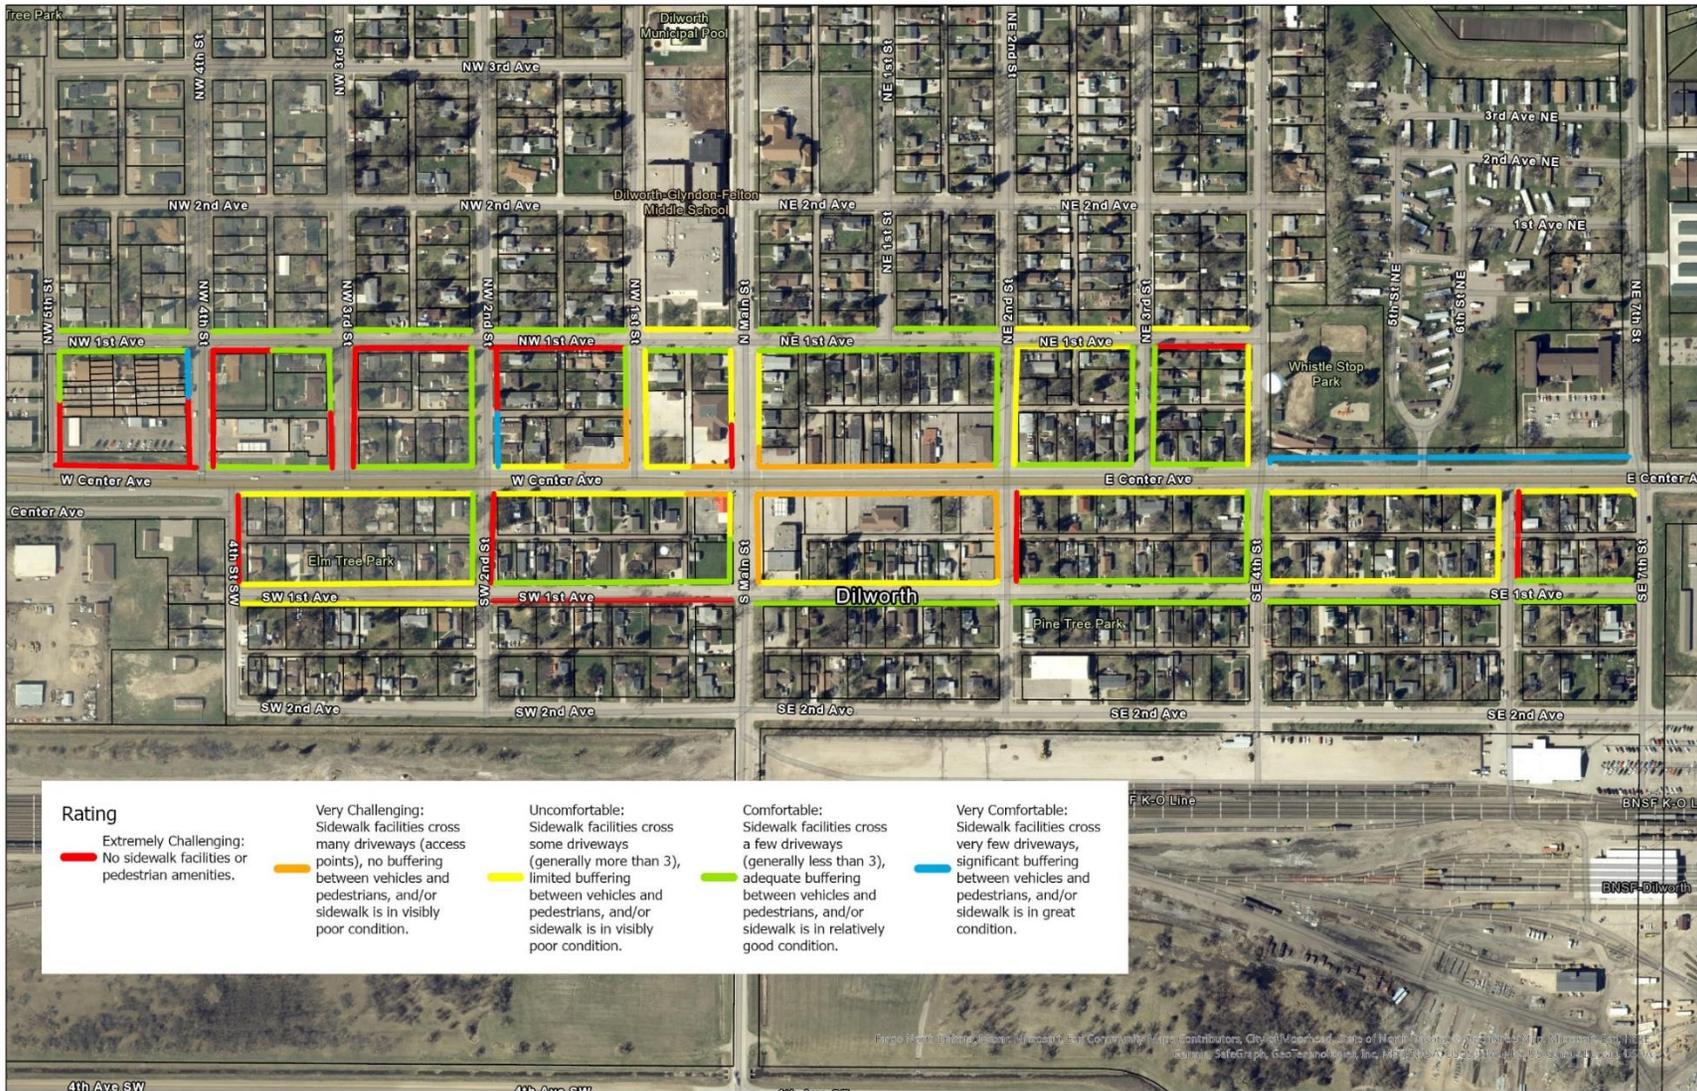
Figure 3 Pedestrian Level of Stress Rating

The assessment used a simple rating system between one (1) and four (4). Zero (0) was used to denote locations where no sidewalks are present, but there may still be pedestrian activity. These rankings were further translated to one's comfort level when using the corridor for walking (see **Figure 3**).

- **Extremely Challenging** (Rating = 0): No sidewalk facilities or pedestrian amenities.
- **Very Challenging** (Rating = 1): Sidewalk facilities cross many driveways (access points), no buffering between vehicles and pedestrians, and/or sidewalk is in visibly poor condition.
- **Uncomfortable** (Rating = 2): Sidewalk facilities cross some driveways (generally more than 3), limited buffering between vehicles and pedestrians, and/or sidewalk is in visibly poor condition.
- **Comfortable** (Rating = 3): Sidewalk facilities cross a few driveways (generally less than 3), adequate buffering between vehicles and pedestrians, and/or sidewalk is in relatively good condition.
- **Very Comfortable** (Rating = 4): Sidewalk facilities cross very few driveways, significant buffering between vehicles and pedestrians, and/or sidewalk is in great condition.

Generally, Highway 10 may be perceived as an uncomfortable environment for pedestrians based on the number of driveway crossings, parking lots, and limited buffering between vehicles. Nearly half of the blocks are considered “challenging” or “uncomfortable.” Sidewalks that are considered “comfortable” are generally located outside of the US 10 corridor along side-streets or parallel routes.

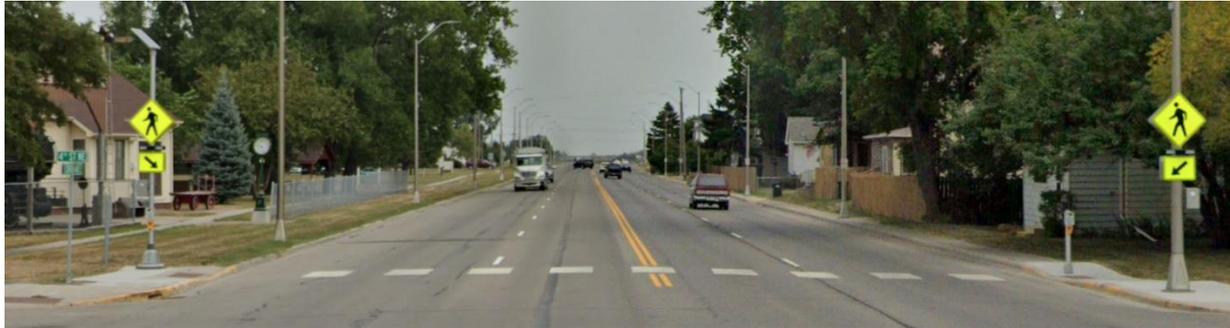
Figure 4 Rectangular Rapid Flashing Beacon at 4th Street E

The pedestrian crossing at 4th Street E was enhanced with a Rectangular Rapid Flashing Beacon (RRFB) system in 2020 as shown in **Figure 4**. While the RRFB provides additional conspicuity to the crosswalk, there is a possibility of a motorist not seeing a pedestrian because their view is blocked by a same-direction vehicle in the adjacent lane. Crosswalks for multi-lane roads may benefit from additional RRFB's and signs mounted overhead or in or a median refuge.

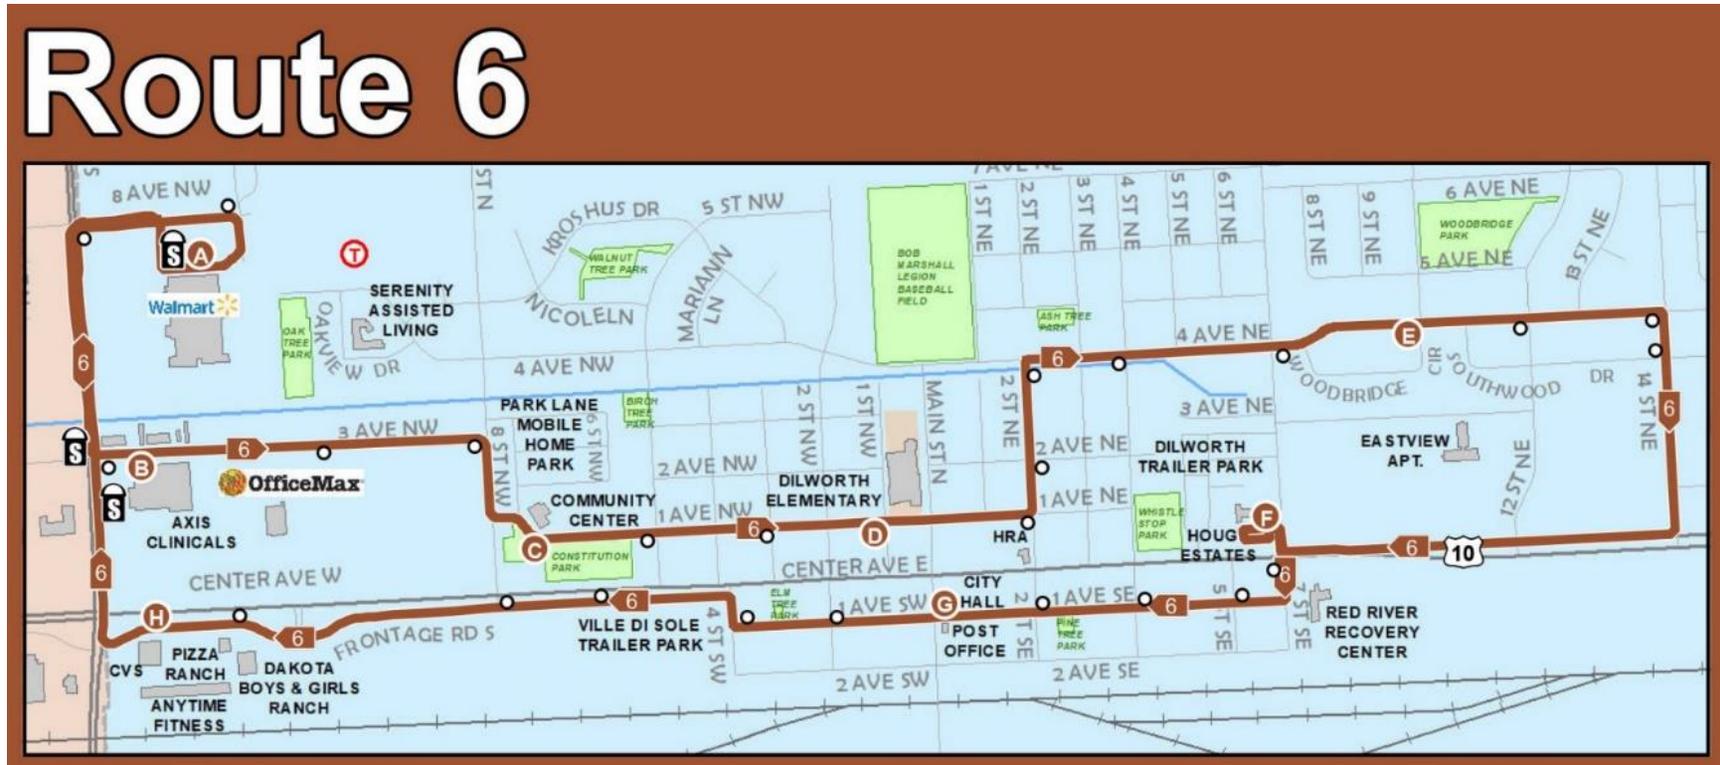
Figure 7 MATBUS Route 6

MATBUS operates one route in Dilworth that travels across the Highway 10 corridor. Route 6 crosses Highway 10 at the 7th Street E and 34th Street Intersections. Between 4th Street E and 34th Street, the route utilizes the frontage road along the south side of Highway 10. It has been noted by MATBUS that the stops along this segment are not ideal and provide poor connectivity to the north side of Highway 10. Ridership data is provided below:

In addition to the 2020 MATBUS rides in 2020, Dilworth MAT Paratransit provided an additional 918 rides and Dilworth Metro Senior Ride provided an additional 639 rides in 2020. These services provide a door-to-door service for seniors and others with mobility concerns. **Figure 7** shows the MATBUS route through Dilworth.

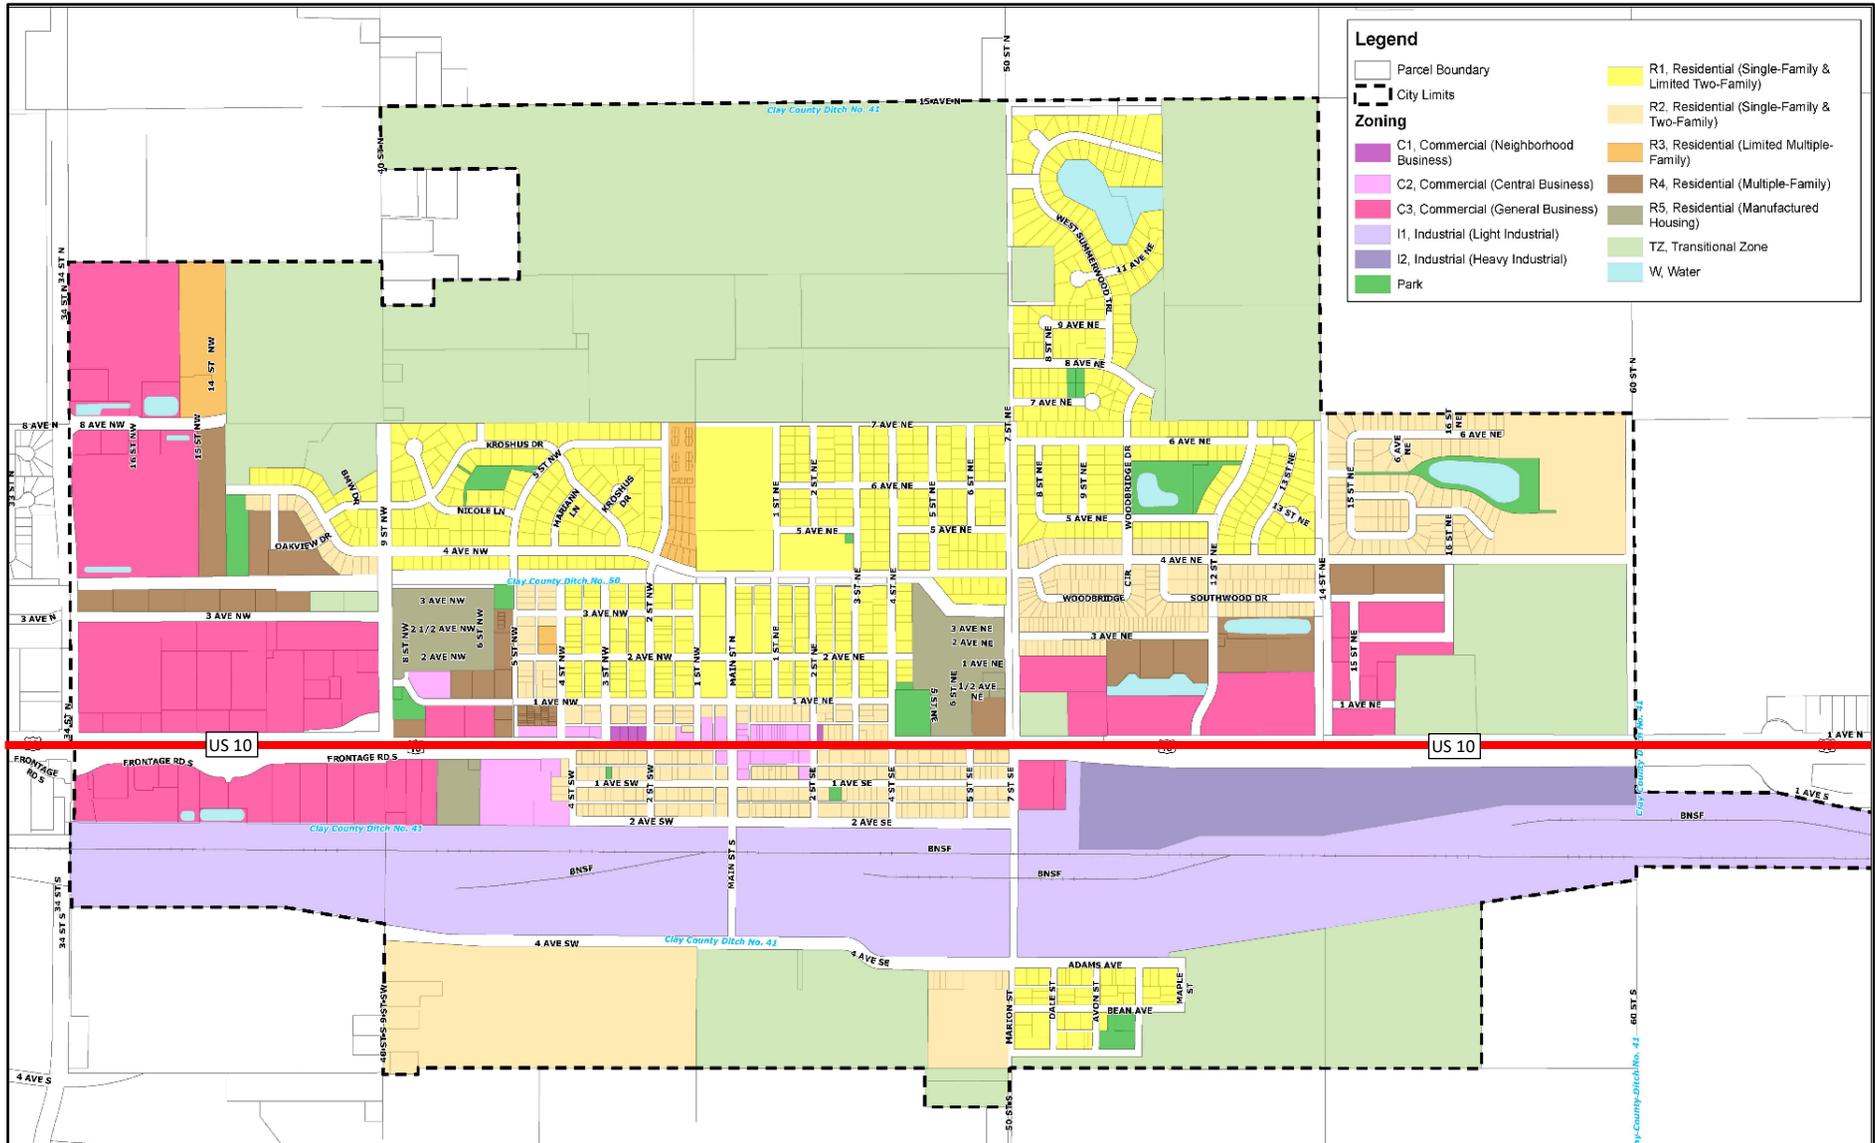
Figure 8 Current Land Zoning

The existing land use areas adjacent to the Highway 10 corridor through Dilworth vary from suburban commercial to urban residential according to the MnDOT Land Use Context Tech Memo. Land use for Highway 10 can be broken in 3 segments. **Figure 8** shows the City’s current zoning map.

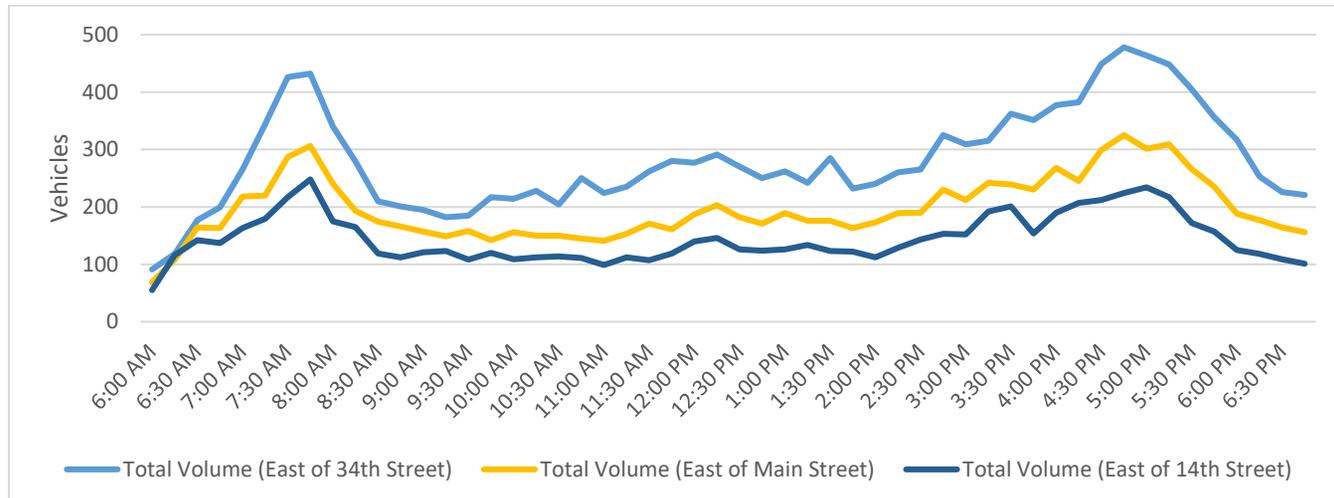
Figure 9 Hourly Traffic Volume Profiles

Based on the traffic data collected, total traffic volume profiles and traffic volume profiles by direction were developed at select locations as shown in **Figure 9** and **Figure 10**, respectively. These profiles help illustrate how vehicular activity varies throughout the day along segments of the corridor. In general, the corridor follows a typical pattern with a defined morning peak occurring between 7:15 and 8:15 a.m. and an evening peak between 4:30 and 5:30 p.m. There is also a defined commuter travel pattern, with a higher westbound traffic pattern during the a.m. peak period and a higher eastbound travel pattern during the p.m. peak period. Traffic volumes generally decrease as you travel from west to east along the corridor.

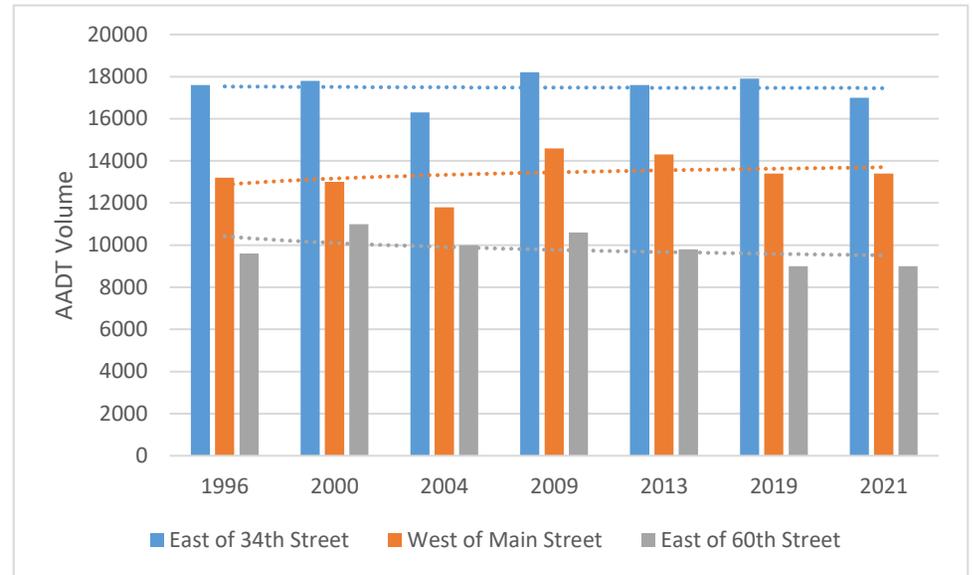
Figure 11 Historical Highway 10 Annual Average Daily Traffic Volumes

Historical annual average daily traffic (AADT) volumes within the study area dating back to 1996 were reviewed to understand area growth trends. Based on the data shown in **Figure 11**, AADT volumes along Highway 10 have been relatively stable over the last 20-years. Although there has been a fair amount of development, this can partially be attributed to area transportation improvements, including the MN Highway 336 interchange construction which occurred during 2003 and 2004, as well as new I-94 Access at 34th Street, which has had an impact on regional travel patterns. Traffic volumes collected in 2021 and 2022 are generally consistent with pre-COVID conditions.

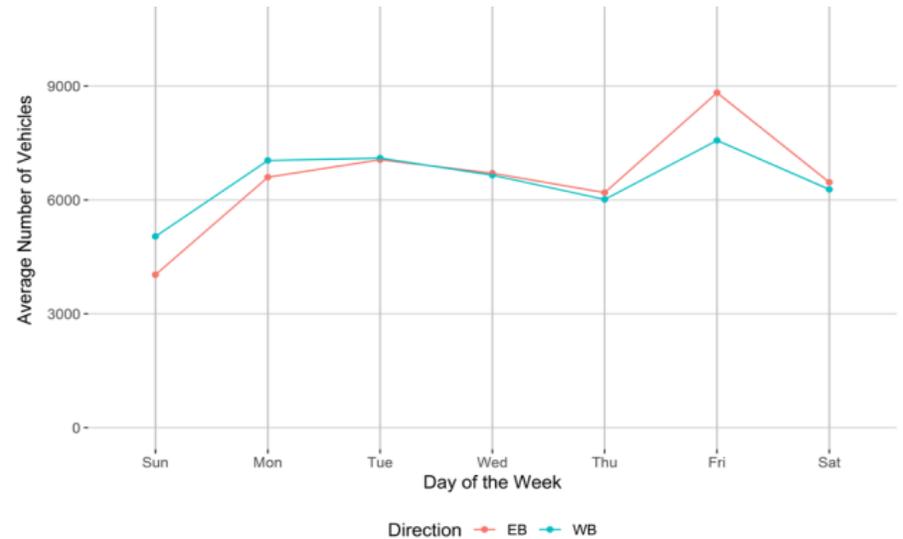
Figure 12 Highway 10 AADT Volumes by Day of Week / Direction

Figure 12 illustrates AADT volume patterns by day of the week and direction along the study corridor. In general, the AADT volumes are relatively steady and balanced between eastbound and westbound between Monday and Thursday. However, there is a noticeable increase on Fridays in the eastbound direction, and a similar increase on Sundays in the westbound direction. This data is consistent with the recreational travel patterns associated with Fargo-Moorhead area residents traveling to/from “lake country” for the weekend.

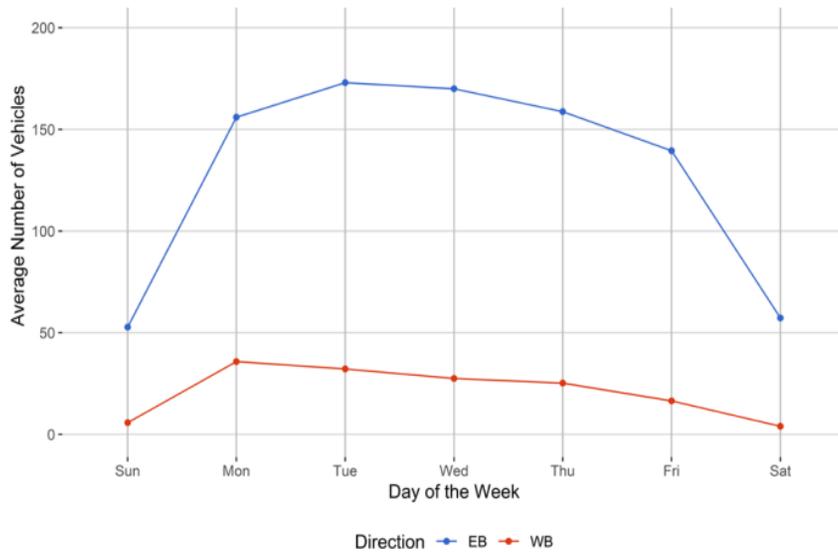
Figure 13 Highway 10 Heavy Vehicle AADT Volumes by Day of Week / Direction

Figure 13 illustrates heavy commercial vehicle activity by day of the week. This data illustrates that truck activity is generally steady between Monday and Thursday, with less activity on Friday, Saturday, and Sunday. The WIM data also identified a higher proportion of truck activity in the eastbound direction, as opposed to the westbound direction along Highway 10. The newly collected data is consistent with these findings, with approximately 10 percent of eastbound vehicles being classified as heavy commercial vehicles and approximately five (5) percent of westbound vehicles being classified as heavy commercial vehicles.

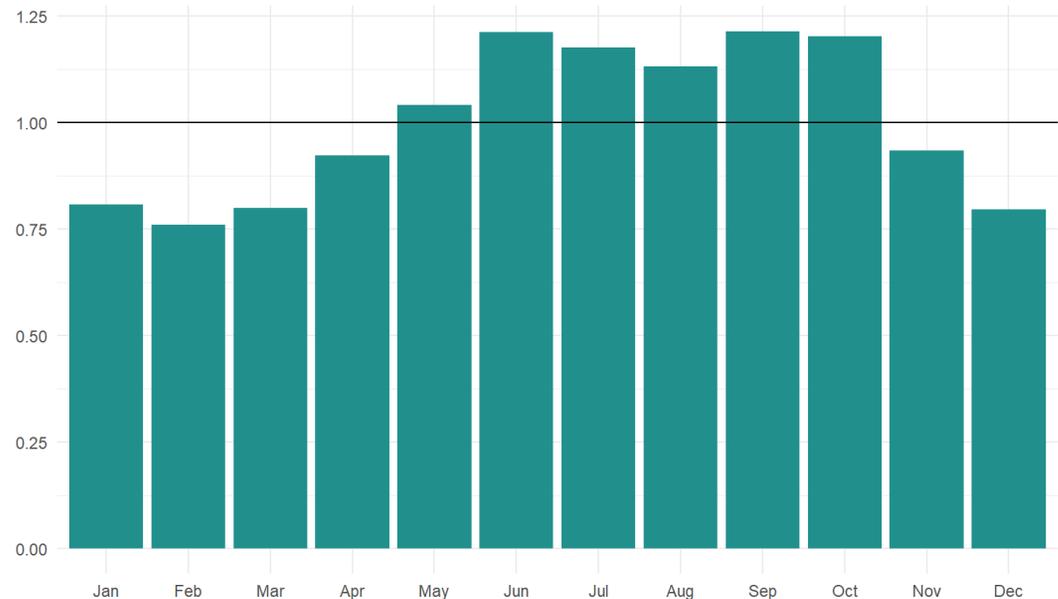
Figure 14 Highway 10 Heavy Vehicle Activity by Month

Figure 14 illustrates heavy vehicle activity by month, with 1.00 being an average month. This data illustrates an increase of approximately 20% in heavy vehicle activity between May and October in the area, which coincides with peak agricultural activity. American Crystal Sugar has a large processing plant located in Moorhead to the northwest of the study corridor and there is a grain elevator to the east of the study area on Highway 10 near MN 336. These businesses generate additional ag-related freight activity during the summer and fall.

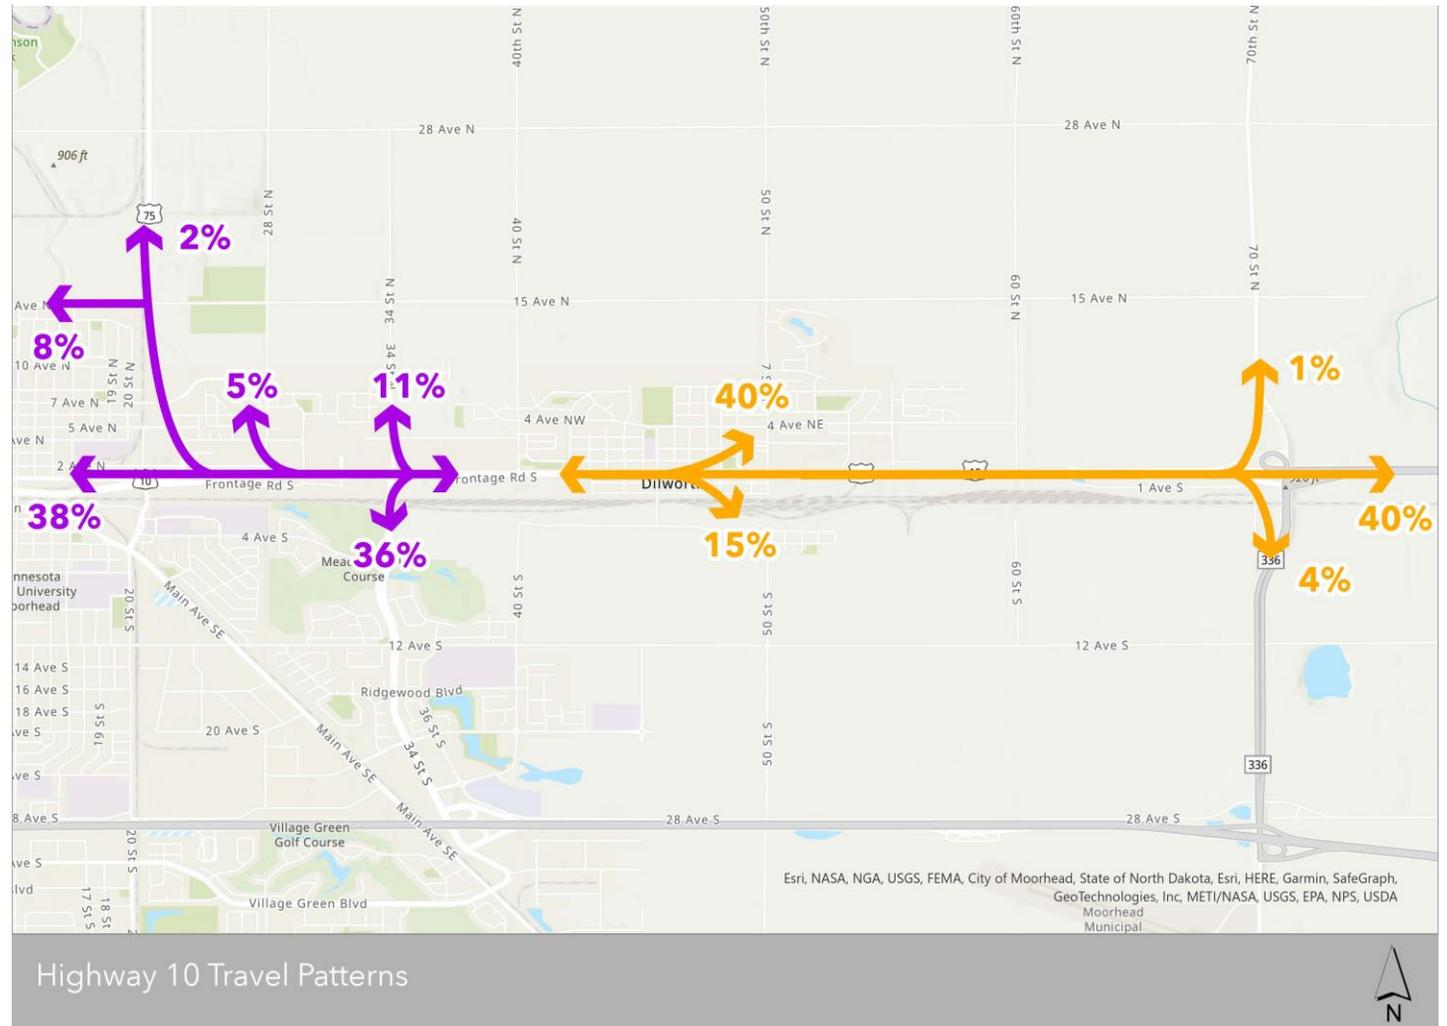
Figure 15 Travel Patterns

To understand who’s using the corridor, a combination of StreetLight data, existing turning movement counts, and land use information was leveraged. This information was organized and summarized into key travel patterns of Highway 10 motorists. The key travel patterns indicate that approximately 55 percent of motorists along Highway 10 (east of 34th Street) originate or are destined to the Dilworth area, while the remaining motorists are traveling to/from MN Highway 336 or Highway 10 (east of MN Highway 336). This is illustrated in orange in **Figure 15**.

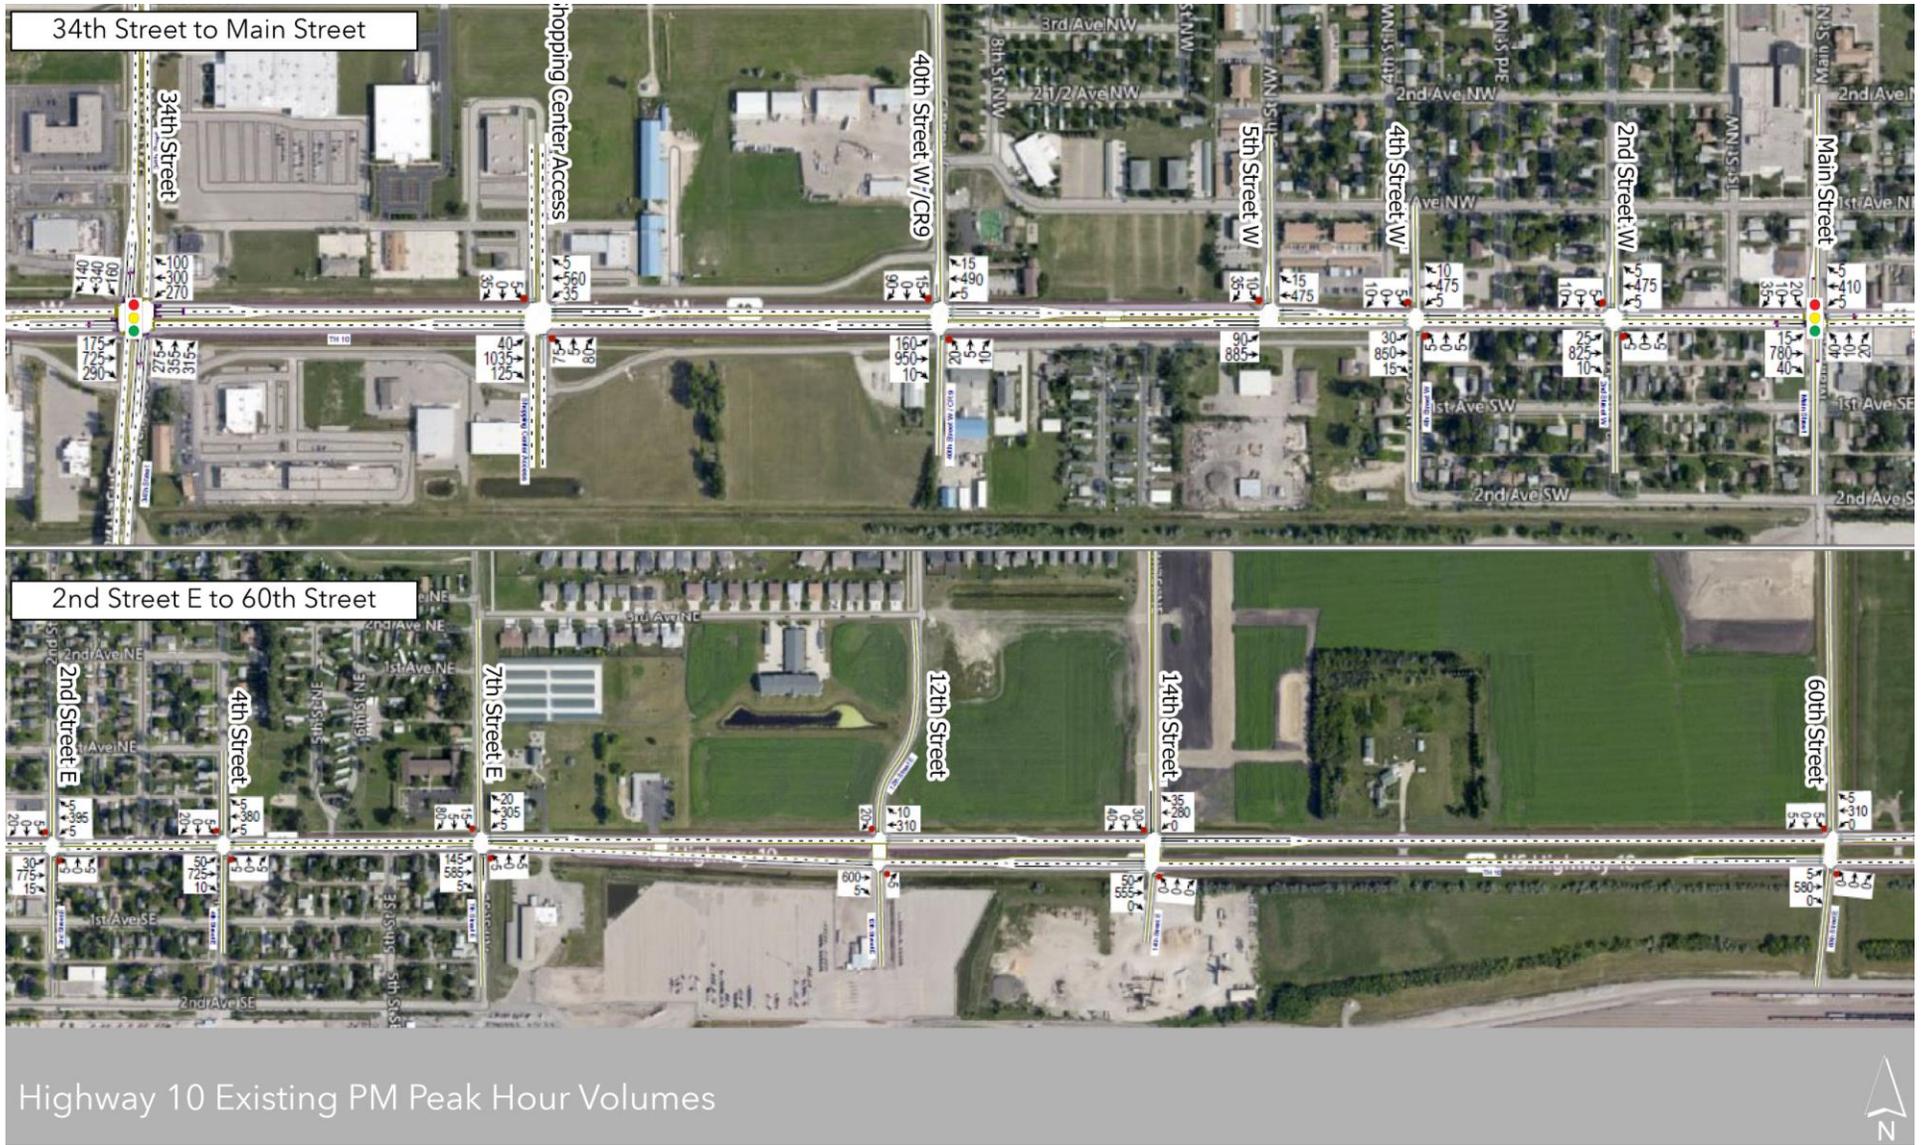
Figure 17 Existing PM Peak Hour Volumes

Existing a.m. and p.m. peak hour traffic volumes are illustrated in **Figure 16** and **Figure 17**, respectively.

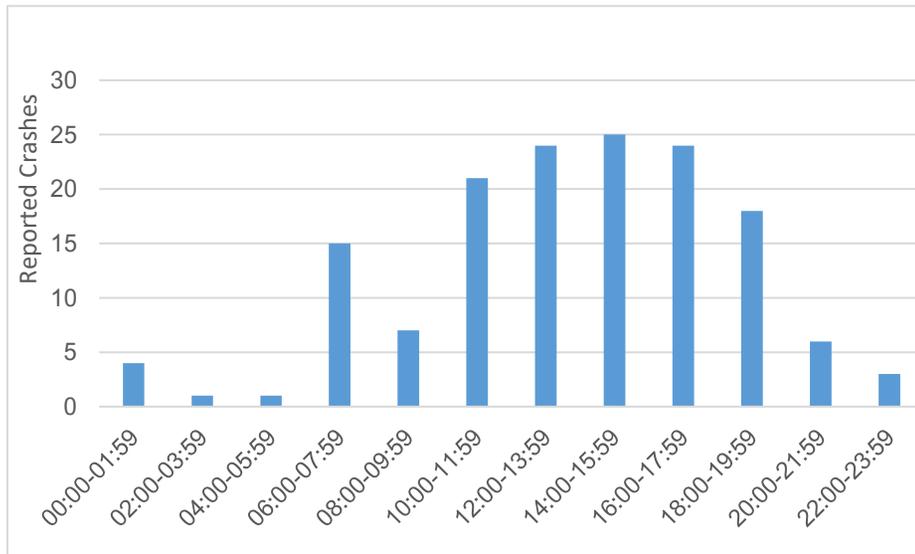
Figure 19 Crashes by Time of Day

The majority of the crashes occurred between 6 a.m. and 8 p.m., with peak crash activity occurring between 12 p.m. and 6 p.m. There is a noticeable increase in reported crashes on Fridays, which coincides with the increase in recreational activity along the corridor. Summaries of the reported crashes by time of day and day of the week are illustrated in **Figure 19** and **Figure 20**, respectively.

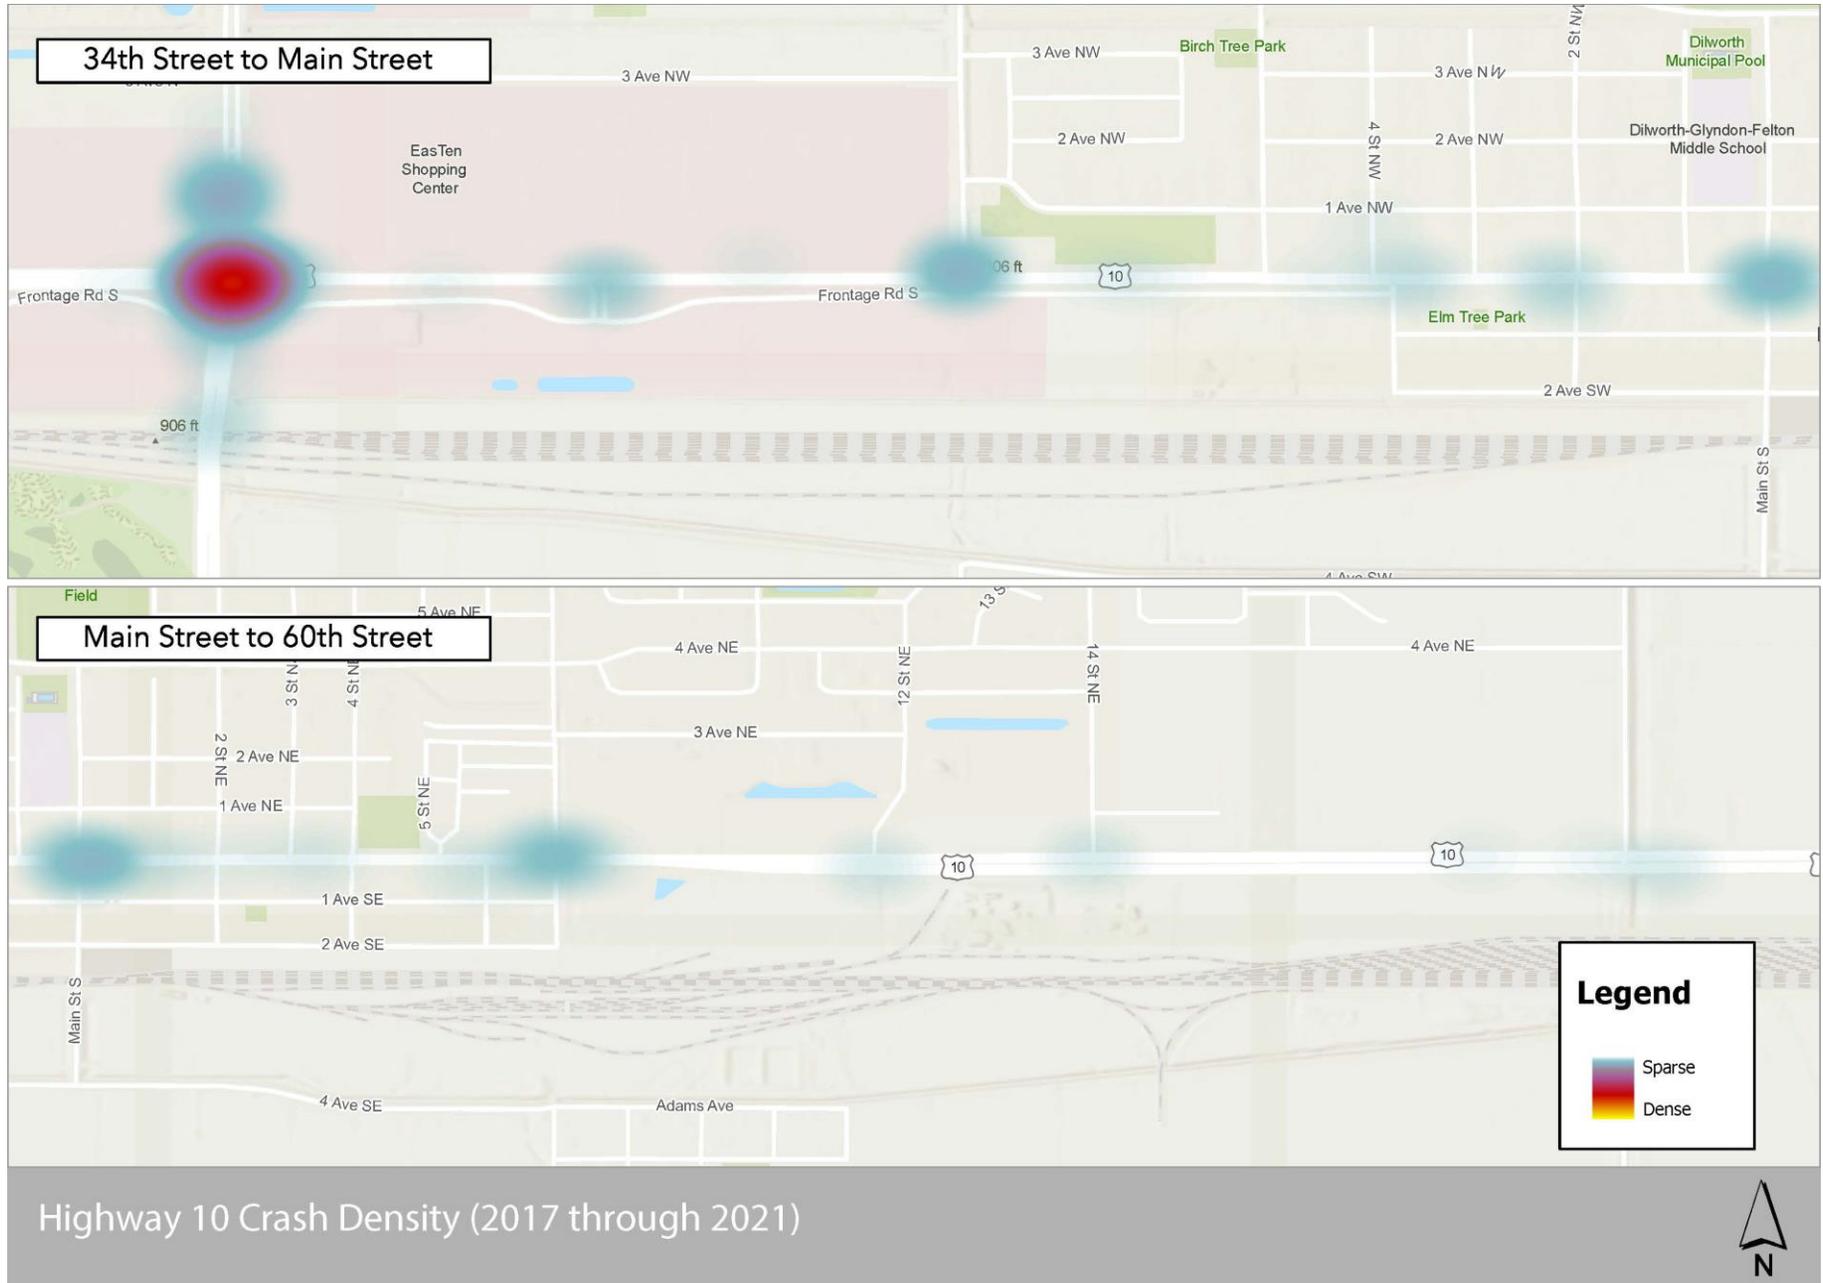
Figure 21 Crash Density

A crash density heat map, shown in **Figure 21**, was developed to illustrate where crashes are occurring along the corridor. Most of the reported crashes occurred at the Highway 10 and 34th Street intersection. The majority of other reported crashes occurred were intersection related, but there was not a specific location that was significantly higher than any other intersection.

As noted earlier, most crashes within the study corridor occurred at the 34th Street intersection. There were 58 reported crashes at the 34th Street intersection during the last 5-years. The crash and severity rates of this intersection are well above the statewide average and critical rates for intersections with similar characteristics. One of the contributing factors in this location is the adjacent access along 34th Street immediately to the north and south of Highway 10, which is within the functional area of the intersection.
