Technical Memorandum 1- Existing Conditions

Highway 10 through Dilworth Corridor Study

Fargo Moorhead Metro COG, MnDOT, and the City of Dilworth

July, 2022

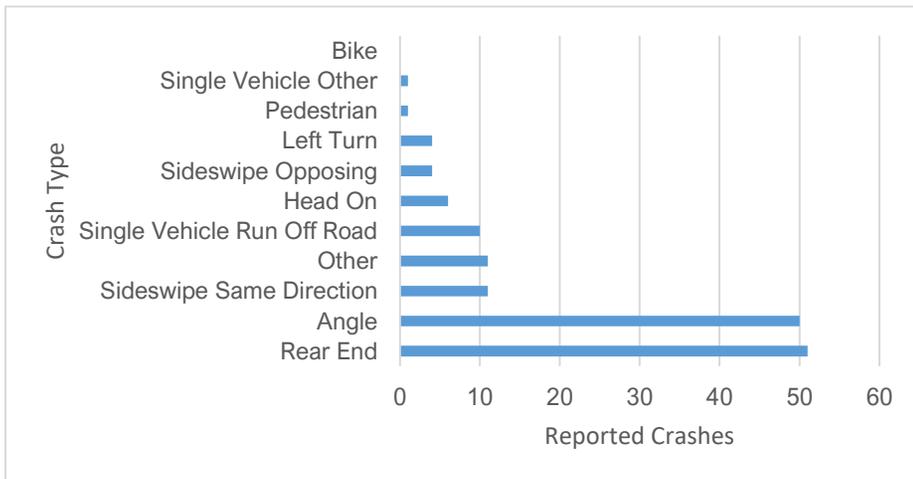
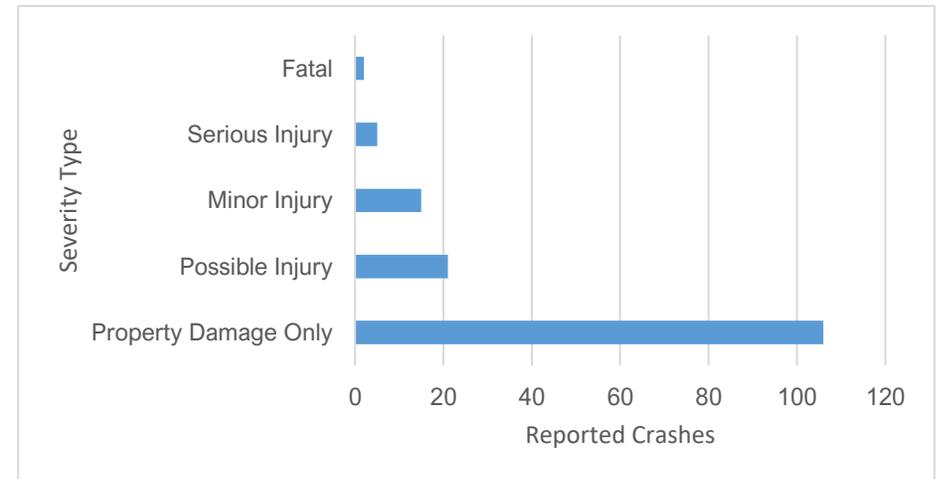
Figure 22 Reported Crashes by Crash Type

Crash types and crash severity were also reviewed as part of the crash history. A summary of the reported crash types and crash severity by location are illustrated in **Figure 22** and **Figure 23**, respectively, while the specific locations are shown in **Figure 24** and **Figure 25**, respectively. This data indicates that most reported crashes were either rear-end or angle-type crashes, which are the most common types associated with corridors with similar characteristics. There was only one (1) pedestrian related crash within the study area, at 34th Street.

From a crash severity perspective, most crashes were property-damage only. There were two (2) fatal accidents and five (5) serious injury crashes. One of the fatal accidents occurred at 34th Street in January 2018 due to a rear-end accident approaching the intersection, while the other occurred at 2nd Street E in September 2021. The crash at 2nd Street E involved a motorcyclist hitting a westbound vehicle on Highway 10. There were no engineering/geometric related issues identified that contributed to the crashes.
